# Anterior Esthetic Restorations Using Direct Composite Restoration; a Case Report

This paper reports a case of a permanent maxillary central incisor with incisal crown fracture treated using composite resin restoration.

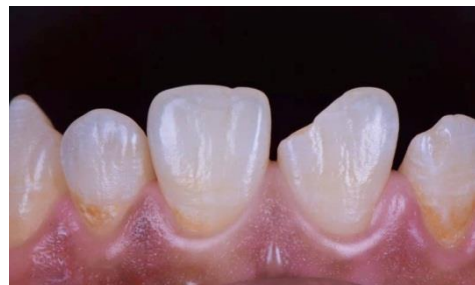
Figure 1: Pre-operative view.

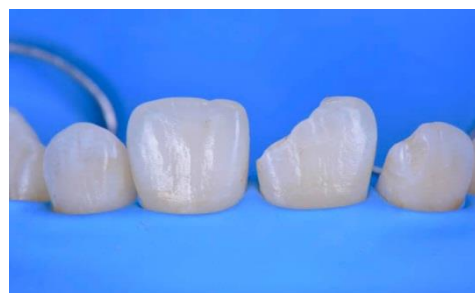
A 9-year-old male patient was referred to the dental clinic of our institution, reporting a dental trauma of the permanent maxillary right central incisor. Dental history revealed that he had a trauma as the result of a fall while playing at school. The patient reported no treatment until that moment, and the crown fragment had been lost during the accident. The position and pattern of the fracture suggested that a composite resin restoration would be a reliable option for the case. The patient was systemically healthy, presented an overall plaque index and gingival index of below 20%, and the operative area was free from visible plaque. The intraoral and radiographic examination showed that the injury had caused a non-complicated crown fracture in the incisal third of the tooth 11, without pulp exposure (Figure1). Clinical examination evidenced fracture involving only the enamel aspect with no symptoms. The coronal analysis of the adjacent central incisor showed incisal edge fracture (Figure 2). Which had already been provisionally restored with composite resin.

Figure 2: Pre-operative view.

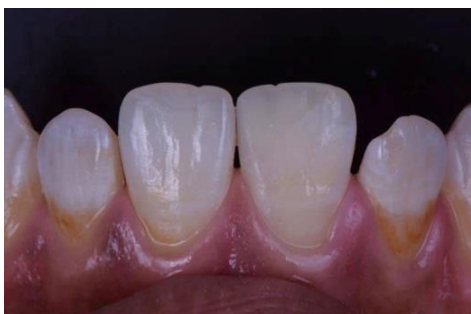
Figure 13: Final view of restoration.
