# Dealing with Endodontist Fear: Retrieval of Separated Instrument. A case report

Shreya Dharni, Dakshita Joy Sinha\*, Nidhi Sharma and Anjali Meena

Conservative Dentistry and Endodontics, Inderprastha Dental College and Hospital, India

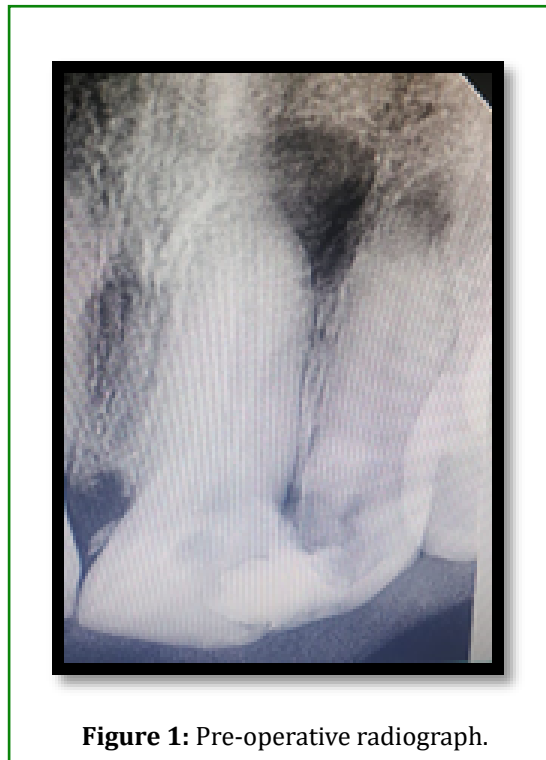
A diagnostic intra-oral periapical radiograph was taken that revealed faulty restoration extending to pulp, and large periapical radiolucency i.r.t 21 22. Electrical pulp testing showed no response. Periodontal ligament widening was evident and a periapical lesion was present.

**Figure 1:** Pre-operative radiograph.

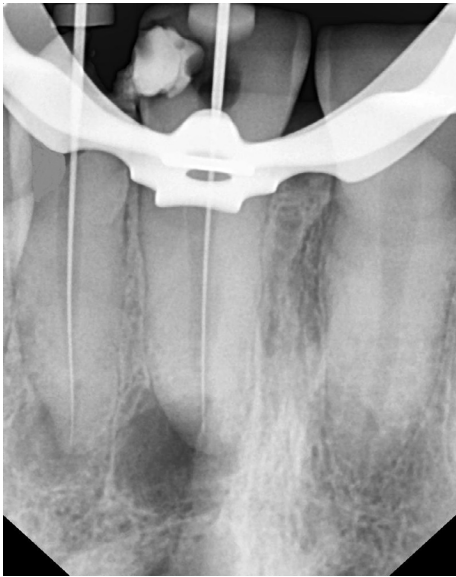
6. Access cavity was prepared using an endo access bur (Dentsply International, York PA).
7. With the help of small-sized instruments (6,8,10 (Dentsply Maillefer K files) the canal was negotiated and the working length was determined with the help of an apex locator (Woodpecker) and later confirmed using a radiograph.

**Figure 2:** Working length radiograph.

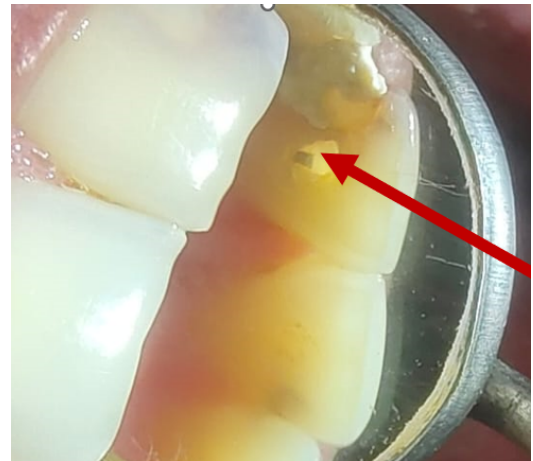
**Figure 3:** Separated Fragment at the coronal end.

8. Cleaning was done till 20K hand file (Mani K files).
9. Then, Cleaning and shaping was done using Neoendo flex rotary instruments (Orikam)
10. Irrigation was performed using 2.5% sodium hypochlorite solution (Qualikems, India) and normal saline (0.9% w/v) during canal preparation.
11. During cleaning and shaping by Neoendo flex rotary instruments (Orikam) 20 4%, the instrument got separated.

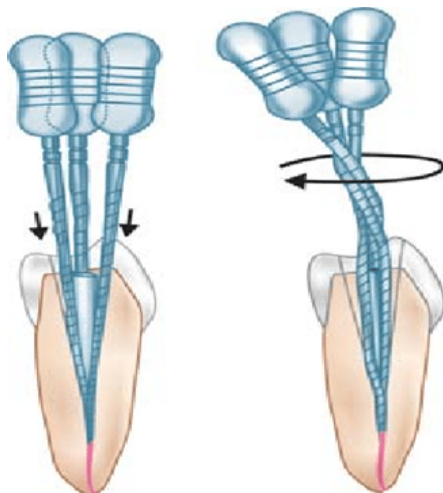
12. The coronal access in tooth 21 was refined using Gates Glidden drills. When the coronal portion of the obstruction was freed from the dentin, artery forceps were guided into the canal to encircle and grip the obstruction.
13. But the grip was not secured enough to pull the instrument out and the fragment kept on slipping even after many attempts.
14. So, the decision was made to use the braiding technique to retrieve the instrument
15. Firstly a #15 k file was inserted into the buccally to engage with the fragment. Then a #20 K file and #25 H file were inserted palatally into the canal to get the grip around the fractured instrument.
16. Braiding of these files and slight outward pull resulted in the instrument being removed from the canal.

**Figure 4A:** Diagrammatic image depicting.

Braiding is a simple technique that can be used to remove fractured instruments from deeper in the root canal. In the file-braiding technique, two or three different sizes of new H-files were gently screwed into the canal alongside the fragment, wound around each other, and withdrawn together with an outward stroke [9]. This method can be effective when the fragment is positioned deeply in the canal and not visible, the clinician is relying on tactile sense, or the fragment is loose but cannot be retrieved by using other means. The largest possible size of files should be used with caution because of the possibility of separation of the braided files [10].

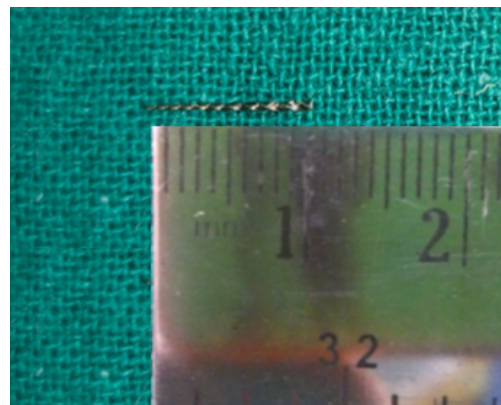
**Figure 4B:** Separated instrument removal braiding technique.

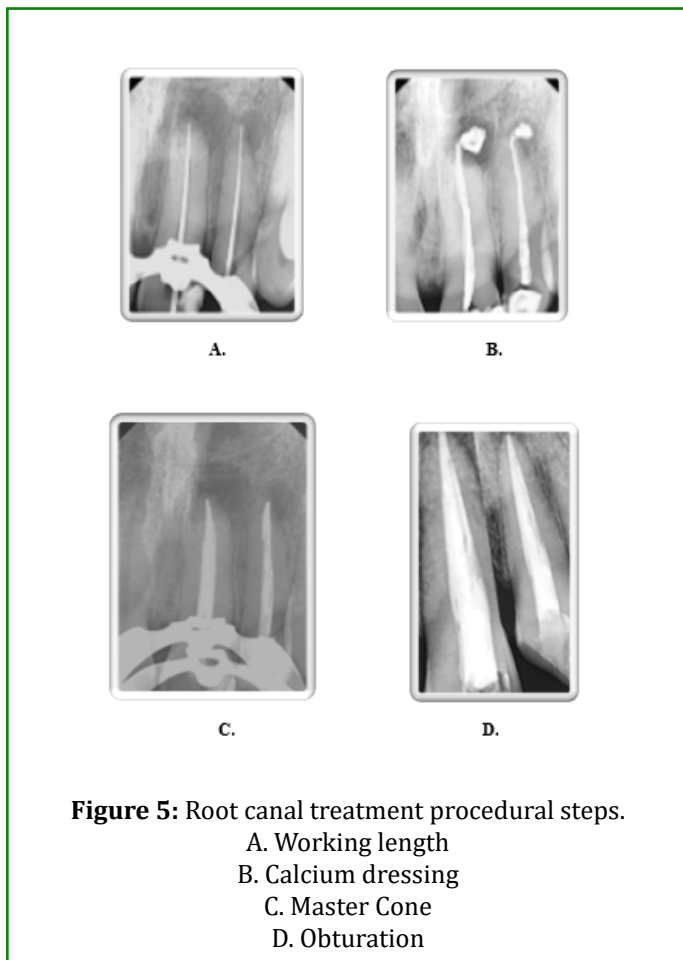
17. Canals were further shaped and cleaned using Neoendo flex rotary instruments (Orikam) up to 30 6 % and irrigation was carried out using 2.5% sodium hypochlorite and normal saline (0.9% w/v) and 17% EDTA.
18. Calcium hydroxide dressing was given for two subsequent visits due to the presence of a large periapical lesion.
19. In the next visit, a master cone radiograph was taken to confirm the correct cone fit up to the working length.
20. Absorbent points were used to dry the canals and obturated using Gutta-percha points (Dentsply Maillefer), sealer (Seal apex sealer, Kerr), and lateral condensation was done and the access opening was restored with glass ionomer cement (GC Gold Label-II).
